56th and Walnut—A Philly Gut Rehab Development

S. Puttagunta, O. Faakye, W. Zoeller
Consortium for Advanced Residential Buildings

July 2013

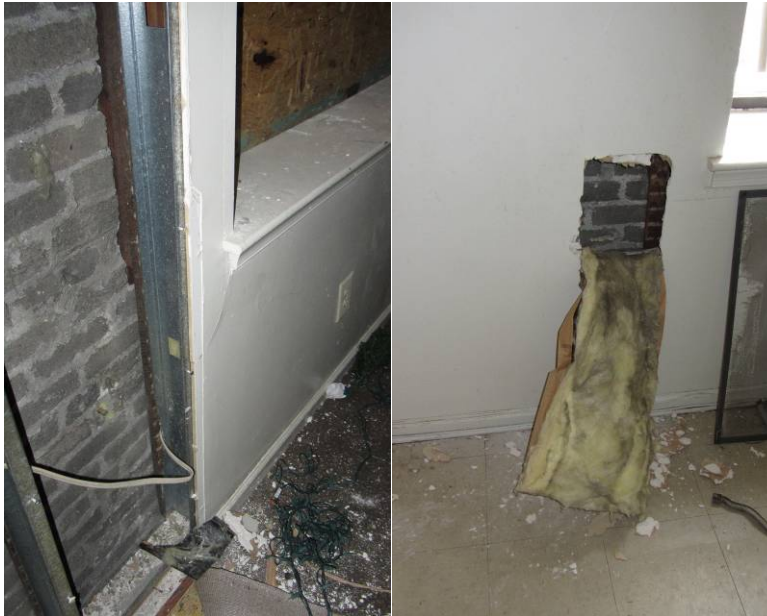
The exterior wall assembly of these apartments comprises multiwythe solid brick-masonry with vertical wood furring between 2 × 4 steel studs at 16 in. on center (o.c.) and the masonry wall (see Figure 3). The steel-stud wall cavities are filled with R-13 Kraft-faced fiberglass insulation. The poor installation (Grade III), conductive nature of the steel studs, and signs of air movement in the wall cavity, as evidenced by the dirt on the backside of the fiberglass insulation, result in a derating of the fiberglass insulation to the equivalent of R-4 cavity insulation.

Figure 3. (L) View of wall assembly construction; (R) spot checks of the batt insulation showed poor installation and air movement within the wall cavity

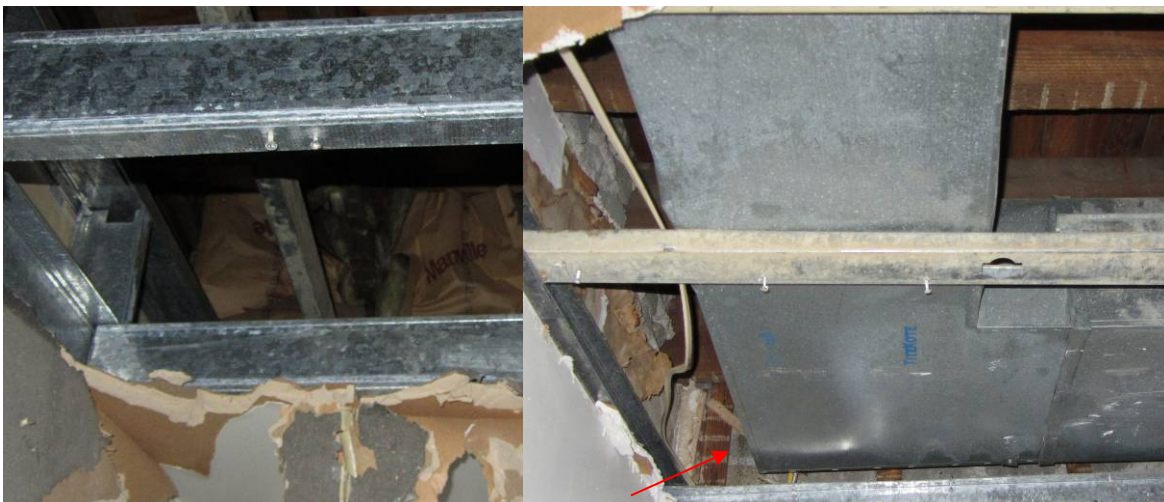
It was also found that the rim/band joist areas were poorly insulated. In some cases, where ductwork ran near the exterior wall, no insulation was found due the duct obstruction (Figure 4).

Figure 4. (L) Poor installation of batt insulation at the rim/band joists; (R) missing rim/band insulation due to ductwork obstruction

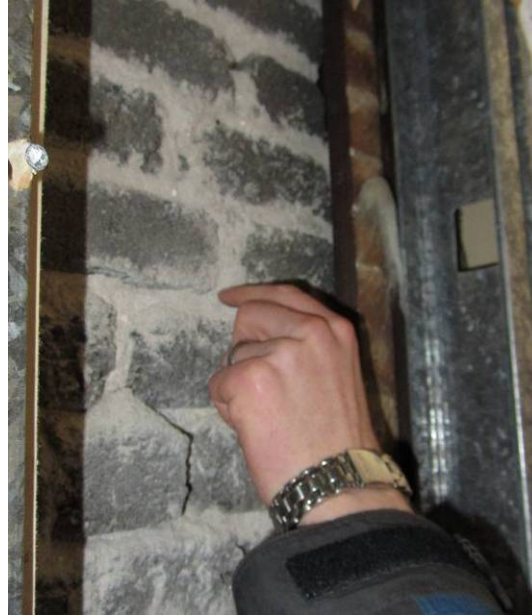
Once the interior walls were gutted, it was observed in a couple small areas that the brick mortar was deteriorating (Figure 5). Cracks in the brick wall were found above these areas. This deterioration was likely a result of a bulk moisture migration breaking down the high lime content mortar of the masonry wall. There were additional signs of moisture issues on several of the window sills, as evidenced in Figure 6, with paint bubbling and the wood sill being soft to the touch.

Figure 5. Brick mortar crumbling just from the touch of a finger

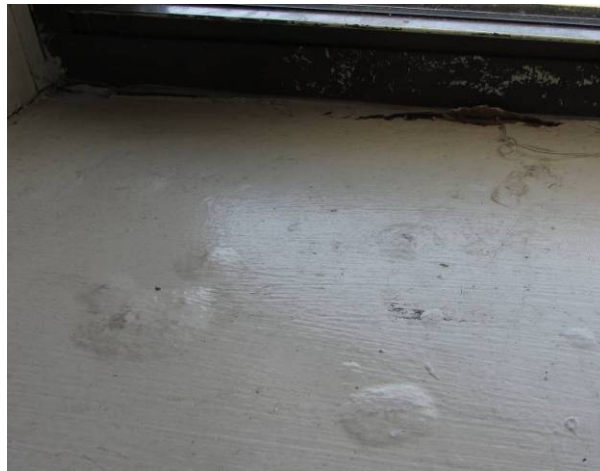
Figure 6. Bubbling of paint on window sill

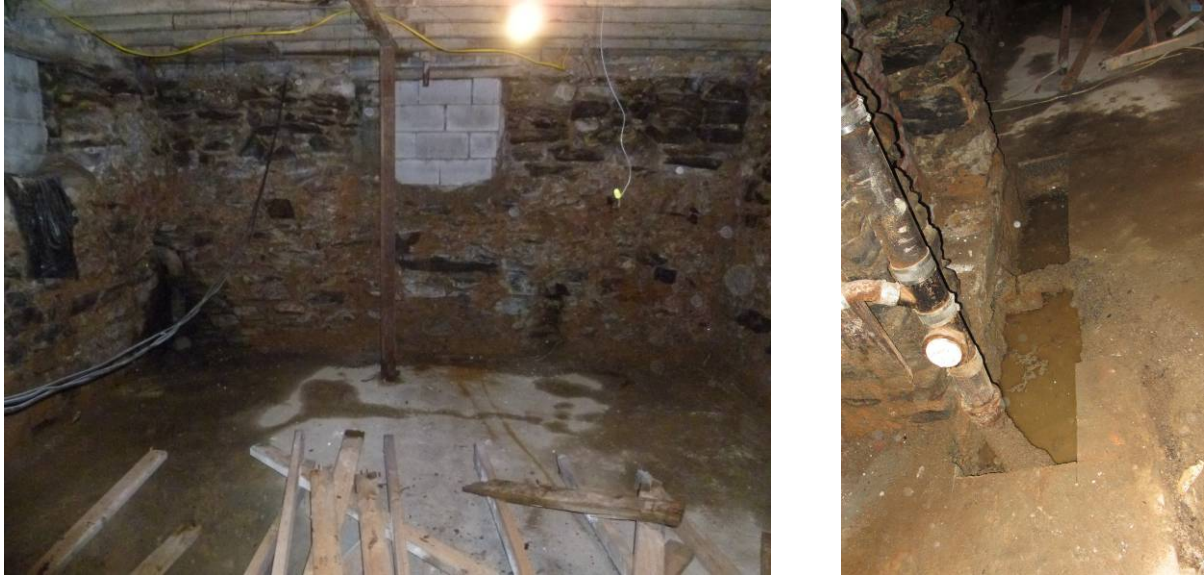
The apartment buildings have uninsulated rubble stone foundations. During the initial inspection, water was observed on the rubble stone as well as the concrete slab. Rarely do these buildings have proper water- and damp-proofing on the exterior of the foundation walls or a capillary break and vapor retarder under the foundation slab. In this portion of Philadelphia, the water table is roughly 12–18 in. below the slab, so moisture continually wicks up into the basement.

Figure 7. (L) The existing foundation has moisture issues with water intruding through the foundation walls and slab. (R) When additional footing supports were being dug, it was clear that the water table is quite high in this area.

Resolving this moisture issue is complicated in existing structures without ripping up the existing slab. CARB offered various alternatives to address this common and significant barrier. These foundation solutions are not cost effective, as they go beyond just energy consumption and address durability, indoor air quality, and comfort issues. The benefits cannot be objectively quantified solely in terms of monetary savings, especially in these apartments, as the basement is common space and not part of any specific apartment.

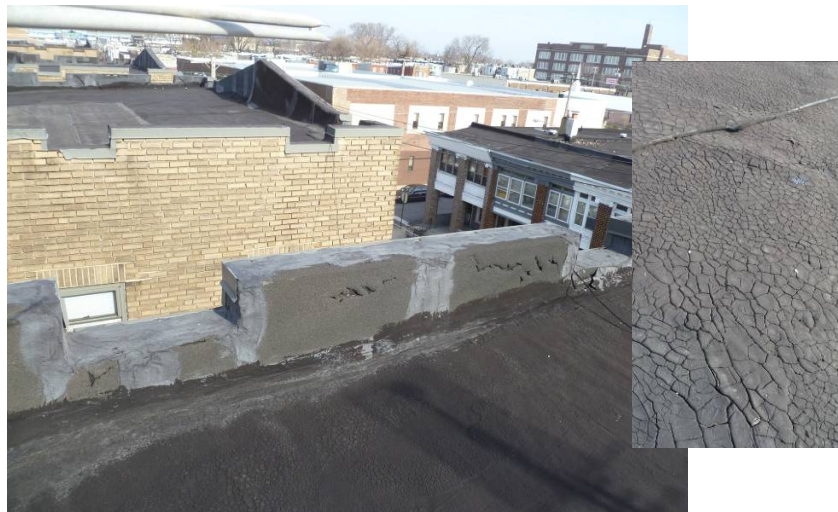
The flat roofs of these buildings were in need of repair to control bulk water, as the asphalt hot-mop roof was deteriorating (Figure 8). Insulation of the roof assembly was R-30 batt insulation installed at the ceiling plane in the unvented cockloft attic space.

Figure 8. Deterioration of roof as evidenced by “alligatored” asphalt coating and degraded coating on parapet

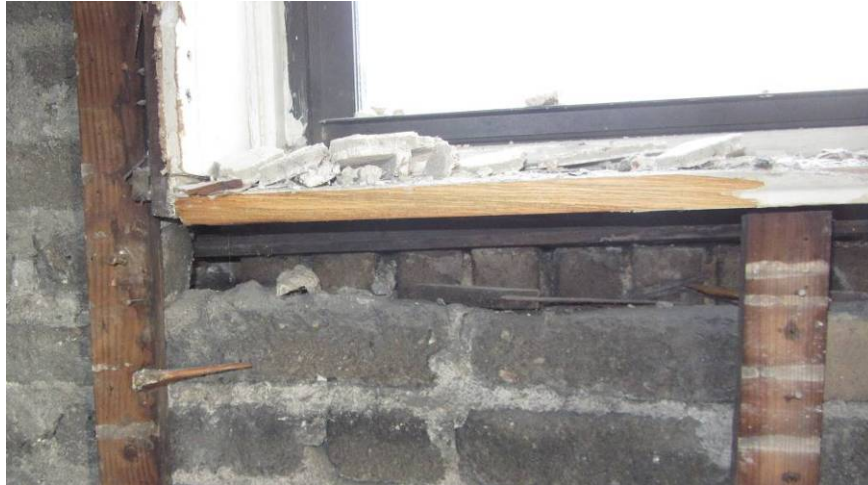
Dual-pane steel-frame windows were installed during the 1990s renovations, but there was no focus on air sealing or insulating the rough window openings. In many instances, the inner brick course under the window sill was knocked out (Figure 9). In addition, in several locations the steel angle headers over windows deflected, allowing additional pathways for air, moisture, and water to enter the wall assemblies.

Figure 9. The inner course of brick was removed when installing the windows back in the 1990s renovation

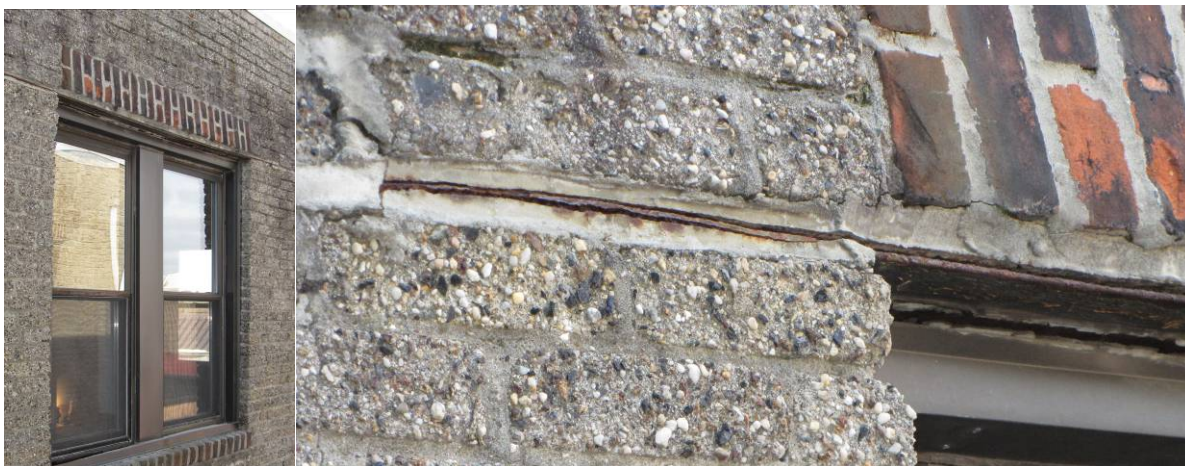
Figure 10. Deflection of steel angle window header

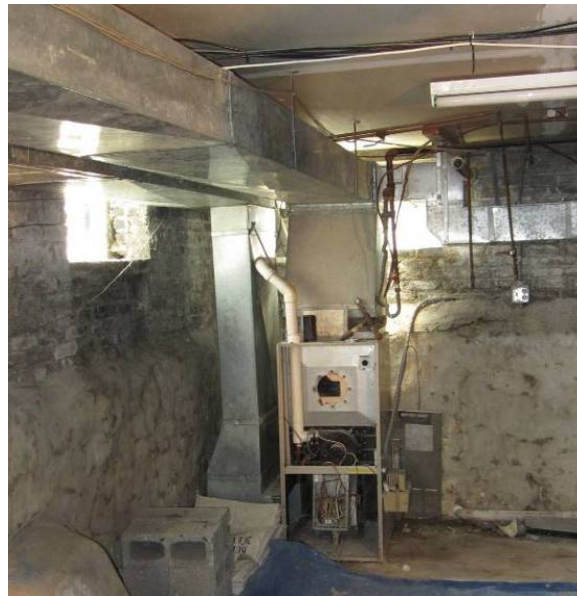
The furnace units had a heating capacity of 45 kBtu/h with a burner efficiency of 90% AFUE. On the cooling side, 2-ton A/Cs with a SEER 10 rating were supplying each apartment. The cooling equipment was in poor condition. The condenser fins on many of these units were dented or damaged, debris was observed on the indoor evaporator coils resulting in restrictions to heat transfer and airflow, and the A/C units hadn't been serviced in years, so the refrigerant charge was likely low. Actual performance was estimated to be SEER 8 or less. Ductwork runs in the basement for the first-floor apartments (Figure 12), between floors for the second-floor apartments, and in the unvented attic space for the third-floor apartments. The existing sheet metal ductwork was uninsulated, in poor condition, and showed no signs of duct sealing.

Figure 12. Uninsulated and leaky HVAC system for a first-floor apartment located in an unconditioned basement

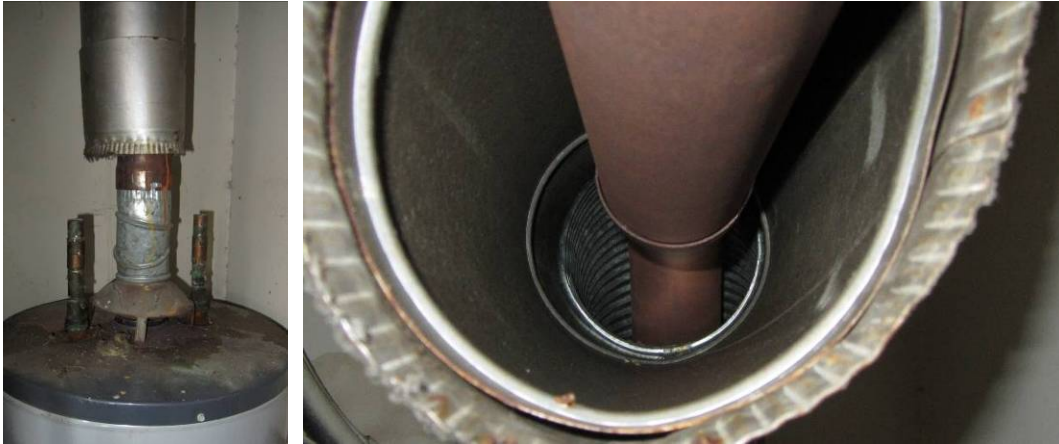
Hot water for each apartment was provided by an atmospheric gas storage tank water heater with an EF of 0.57. In two apartments, the water heater had been replaced more recently with a power/direct venting system (0.63 EF). To provide make-up air for the atmospheric water heaters, the installing contractor made a concentric flue, as shown in Figure 13. This is not a recommended practice.

Figure 13. Make-up combustion air being provided for the water heater

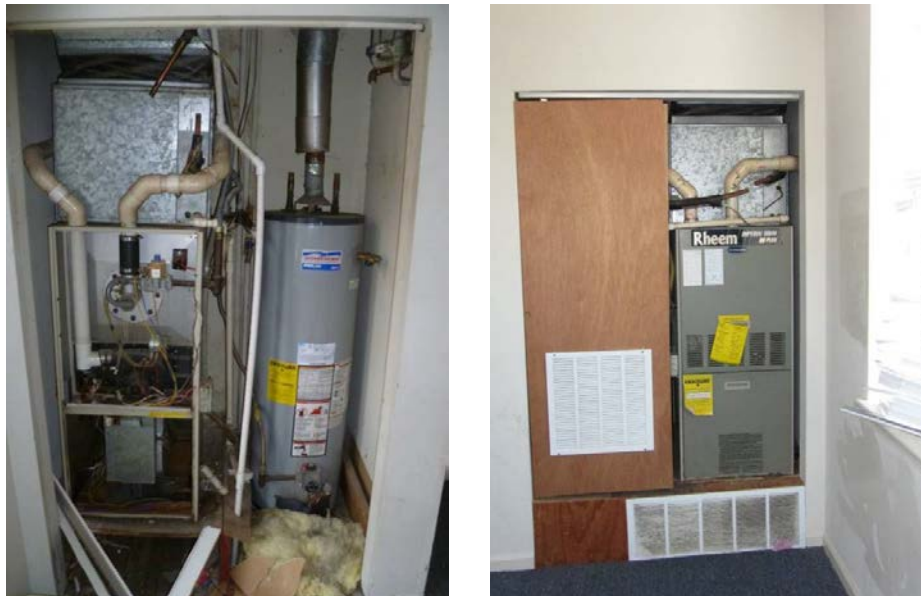
Of greater concern is the location of the atmospheric water heater, as it is located in a bedroom mechanical closet with the furnace. The issue is that the furnace utilized a central return. This central return was a platform box under the furnace with a grille facing the closet door. The closet door also had a transfer grille cut into it to draw air from the main living space. With the high amount of air leakage around the return plenum platform, there is the potential for the return to cause the mechanical closet to be depressurized and lead to back-drafting of the water heater (spilling flue gases, including carbon monoxide (CO) back into the living space).

Figure 14. Atmospheric water heater located in furnace air handler closet with poorly sealed central return

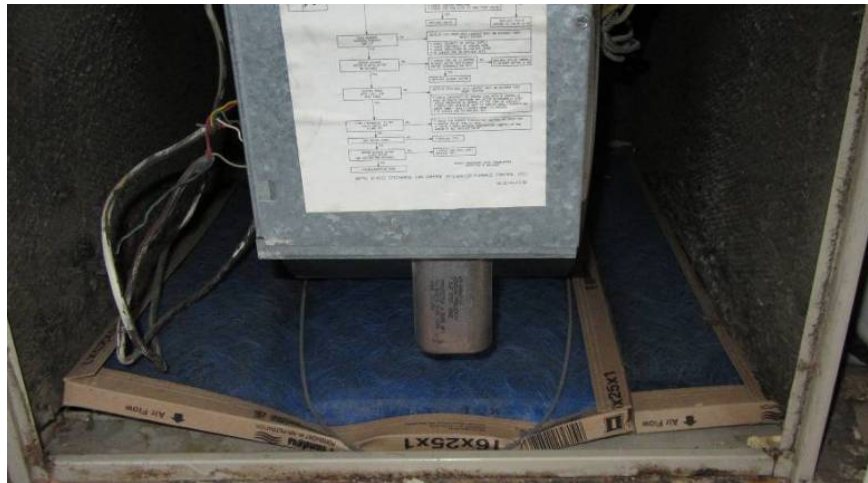
An additional health concern was the improper filtration of the existing furnaces. In several instances, improper filters were installed in the furnaces as the filter size was not a standard option. The filters shown in Figure 15 are both the wrong size for this furnace cabinet and improper media filter material to provide appropriate particulate removal capacity. Filters are classified by a minimum efficiency reporting value (MERV). Fiberglass panel filters tend to have MERV ratings of 4 or less and will tend to have a dust spot efficiency of less than 20%. At a minimum, a 1-in. pleated air filter is recommended to remove more particulates (3–10 pm particle size) from the air stream, but this type of filter needs to be accounted for in the HVAC design to not adversely affect system airflow. A 1-in. pleated air filter will typically have a MERV between 5–8 and have a dust spot efficiency between 20%–75%.²

Figure 15. Improper air filters installed into existing furnaces

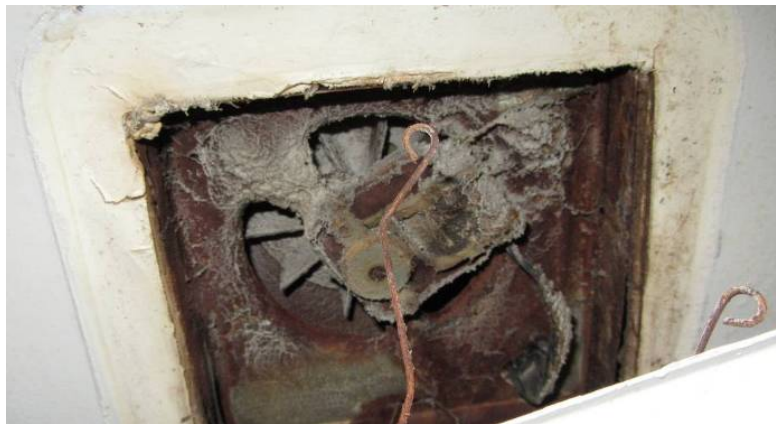
These apartments did not have any whole-house ventilation installed. Still, the local exhaust ventilation in the kitchens and bathrooms was poor or nonexistent. Bathroom fans were quite old and haven't been maintained at all, as shown in Figure 16. Kitchen range hoods were not ducted to the exterior.

Figure 16. Condition of existing bathroom exhaust fan

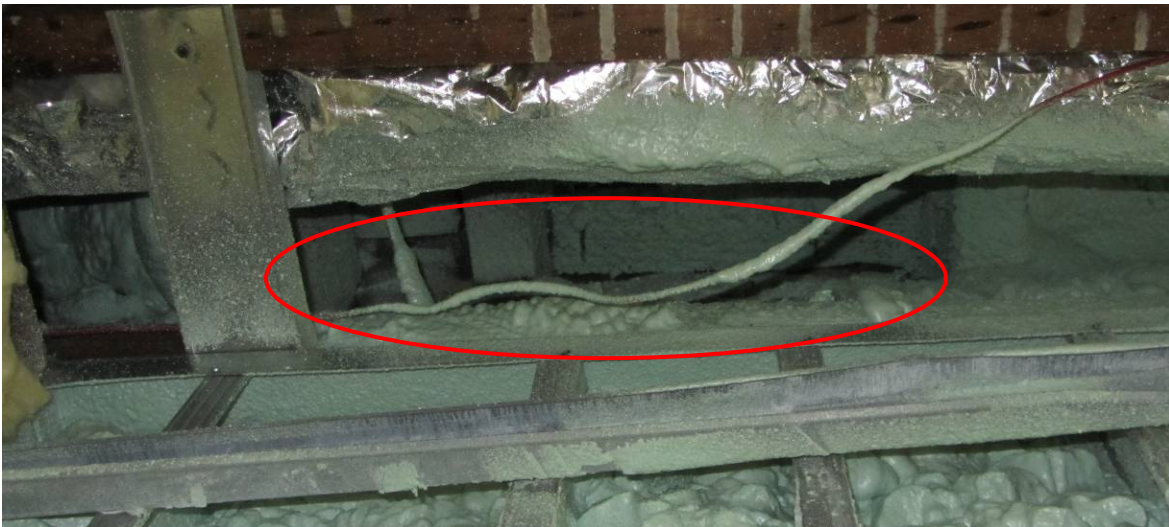
ccSPF insulation applied to the roof deck roof was difficult in some instances due to the sequencing of the contractors. The ductwork rough-in was done prior to the roof underside insulation. In certain locations, ducts were hung close to the underside of the roof deck, making applying the ccSPF difficult (Figure 25). In addition, the complex framing typical of low-sloped cockloft-type roof cavities in older buildings was challenging. The arrangement of roof rafters, ceiling joists, and vertical compression struts connecting the two form voids and narrow gaps that are difficult to access and fill (Figure 26). CARB recommended that the schedule be adjusted in the future to allow for the insulator to come out prior to installation of the mechanical duct rough-in, so the roof deck can be insulated without any obstructions. This would allow a better line of sight and physical access for the spray gun to apply insulation.

Figure 25. Minimal ccSPF insulation against the roof deck due to obstructive ductwork

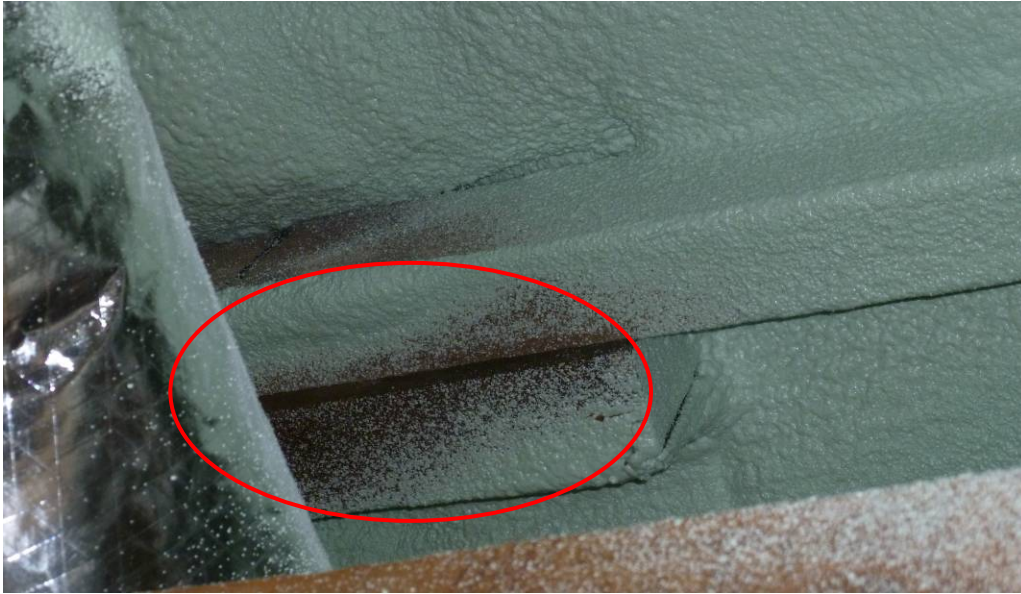
Figure 26. ccSPF should be applied to the whole length of these “sister” trusses to seal gap

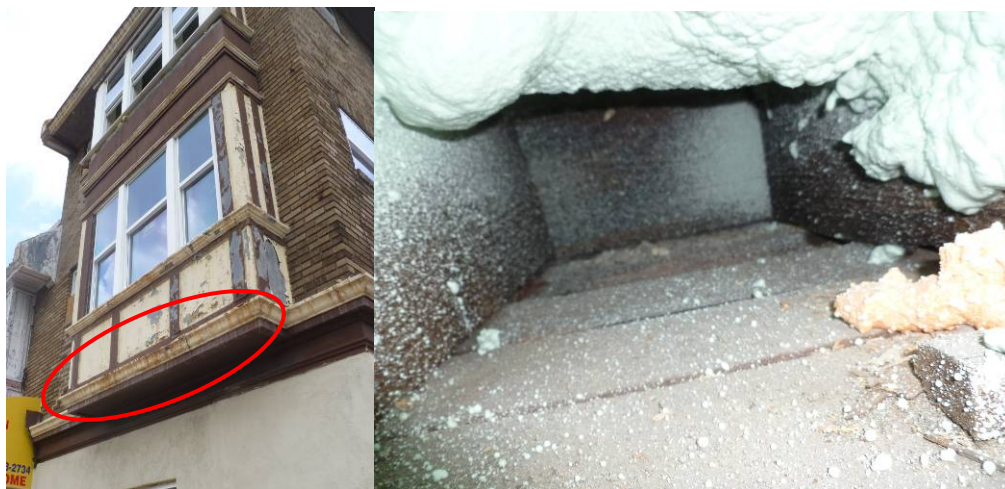
One of the buildings has a window bay projection (Figure 27). The overhang at the exterior window bay bump-out was insulated at the subfloor with ccSPF insulation, but no air/thermal block was installed in the floor joists where the overhang meets the exterior wall. Therefore, cold air could leak into this overhang and travel through the floor joists between the conditioned apartments. CARB recommended using rigid extruded polystyrene insulation to provide a thermal barrier. The corners of the rigid insulation were sealed with spray foam to provide a continuous air barrier.

Figure 27. (L) Location of thermal/air bypass in exterior wall bump-out; (R) Looking from the interior ceiling out into the floor overhang of the window bay

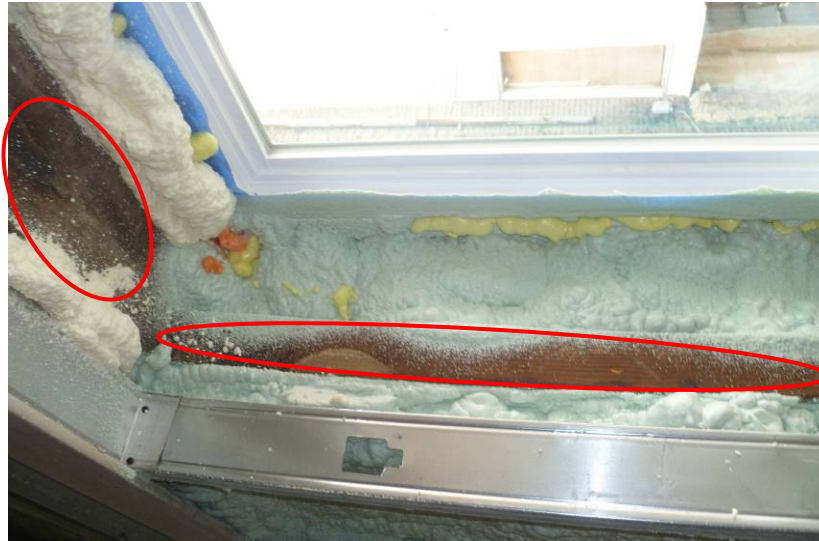
Several of the window sills were not well insulated. As shown in Figure 28, there were uninsulated brick surfaces and wood bucks at the window rough openings. CARB recommended

Figure 28. Missing ccSPF insulation around window rough opening

that the ccSPF extend the full depth of the window rough opening or rigid extruded polystyrene insulation be installed.
