# OBSERVATIONS OF PV SYSTEMS POST-HURRICANE

Eliza Hotchkiss and Andy Walker

2018 Photovoltaic Reliability Workshop  
February 27, 2018  
Golden, Colorado

NREL/PR-6A20-71040

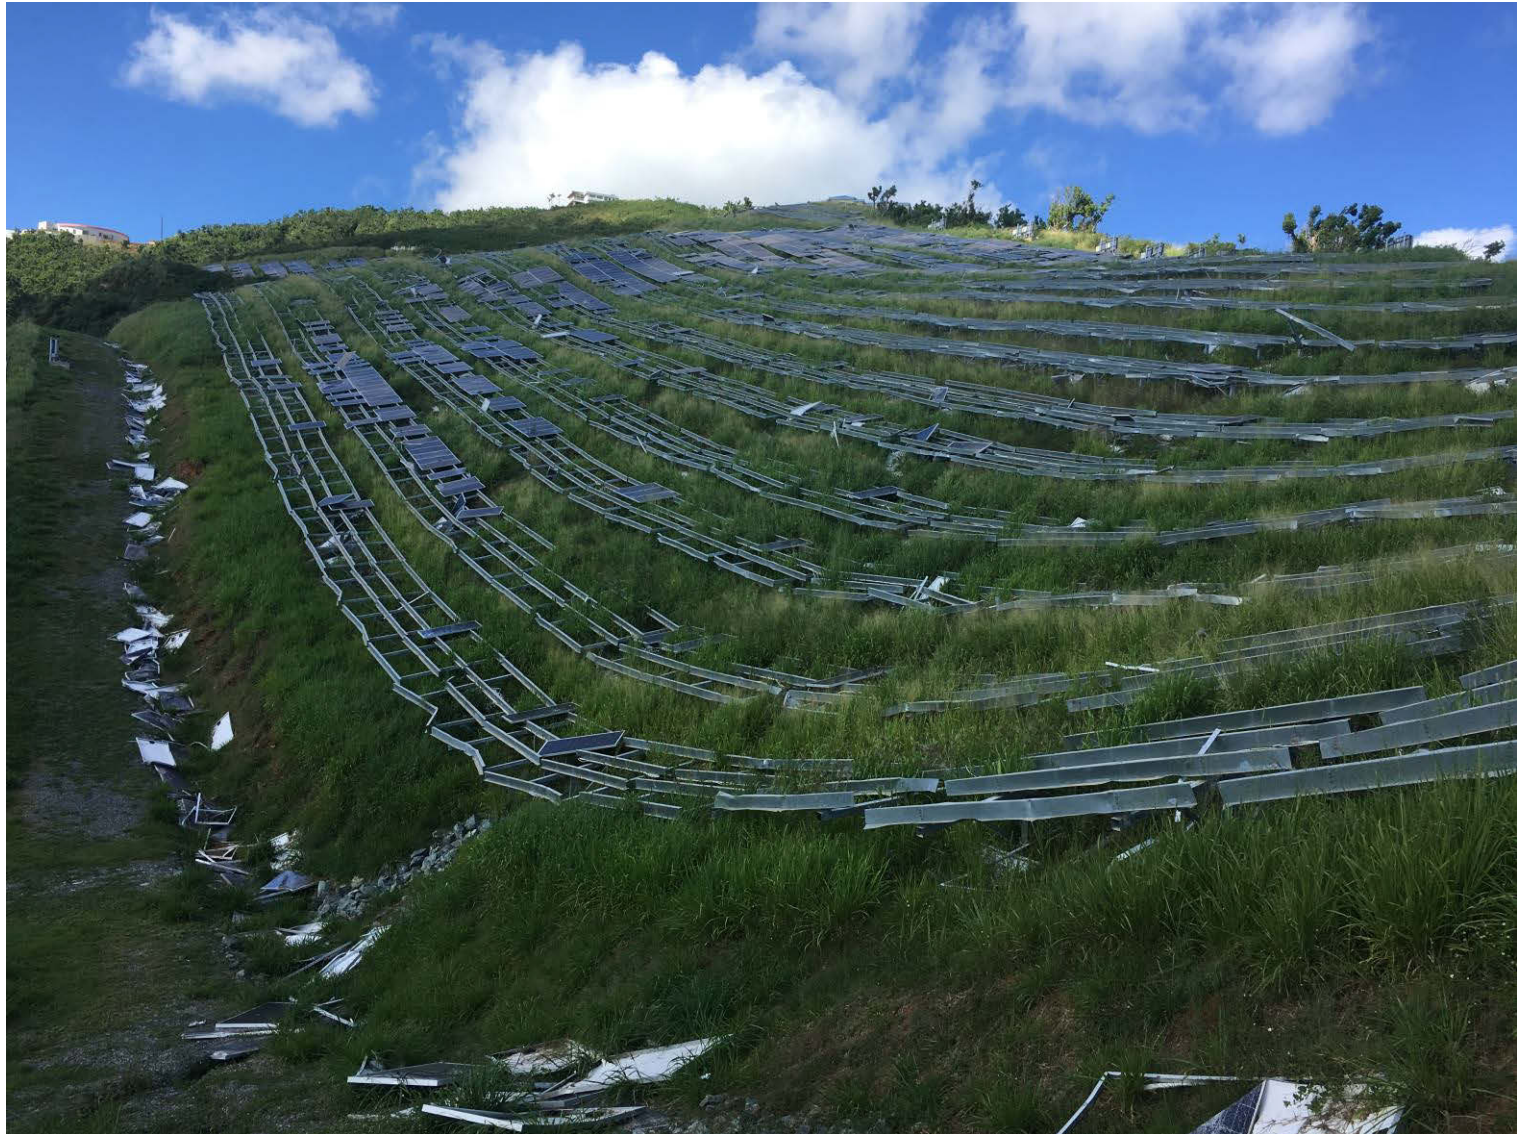
**Same plant after Hurricane Irma, December, 2017**

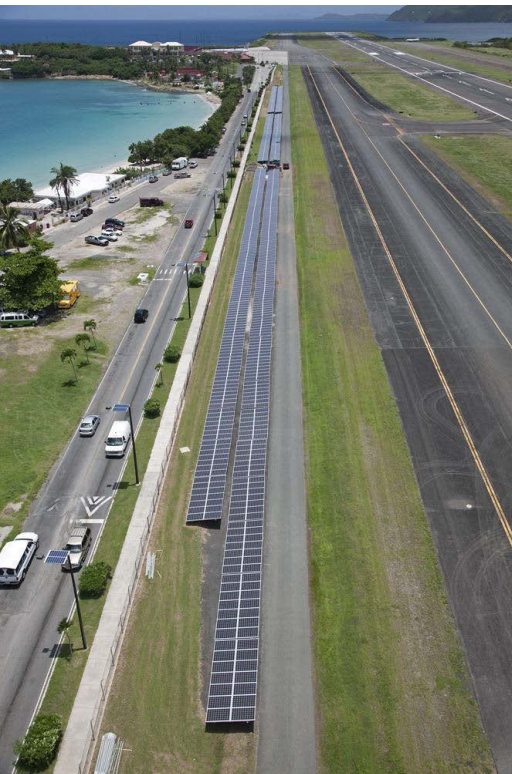
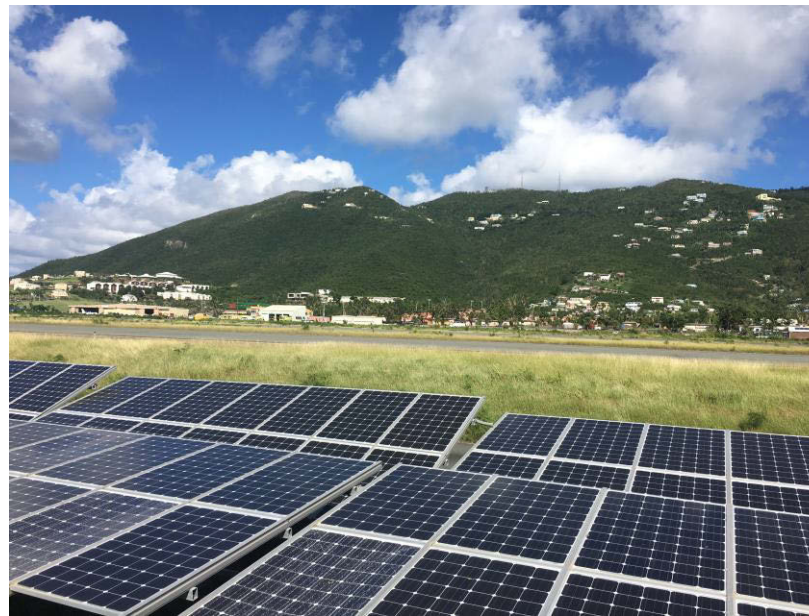
- Inverter 1 – 135 kW
- Inverter 2 – 250 kW
- Last data received at 11:32am Sept 6, 2017

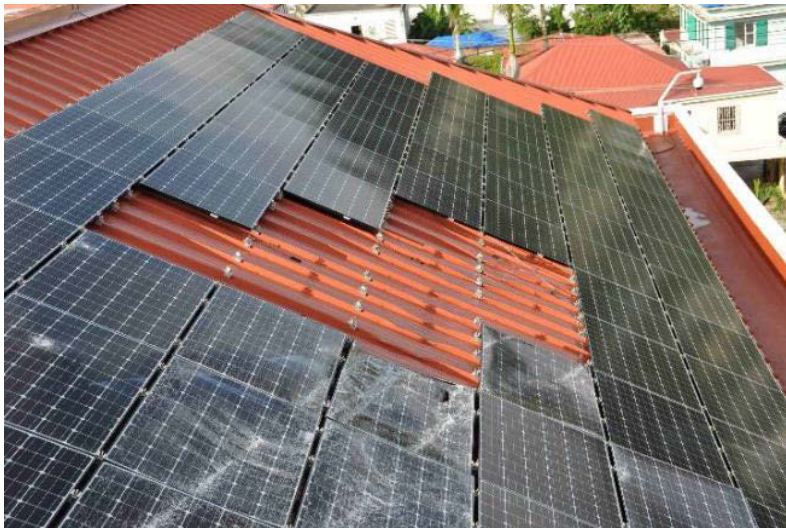
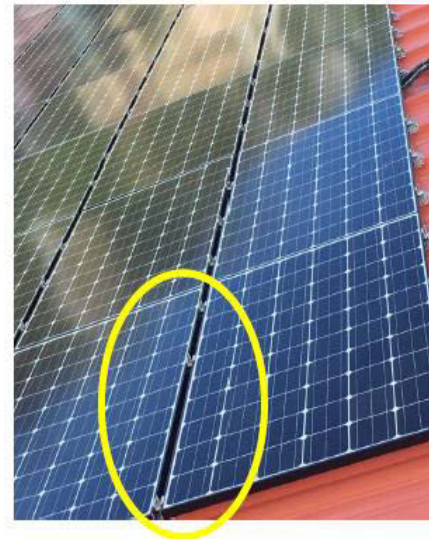
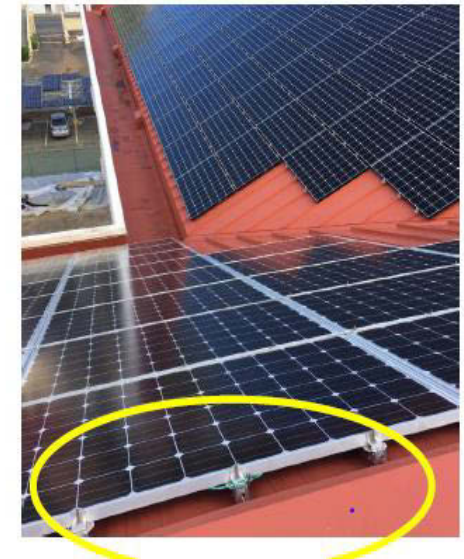
- Roof mounted PV prevalent across USVI
- Wind load criteria is included in ASCE 7-16 (residential and commercial)
- Performance varied greatly
  - Failure mainly due to clips that attach to rails
  - Panels became windborne debris
  - Panels also damaged due to debris (e.g. collapsed antennae)

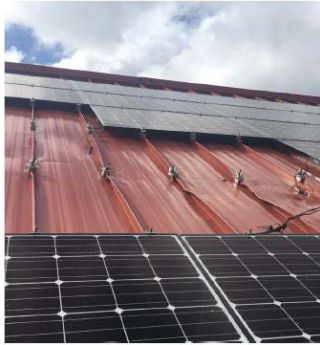
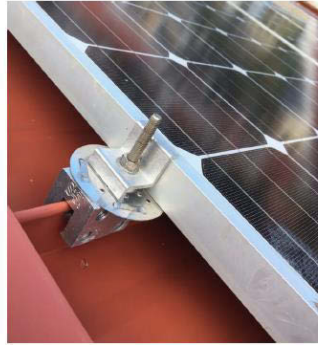
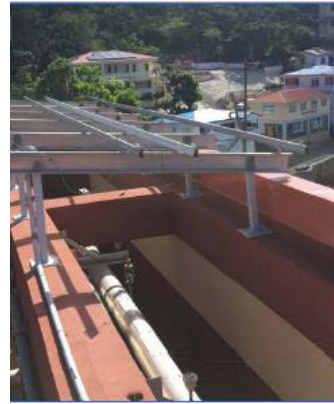
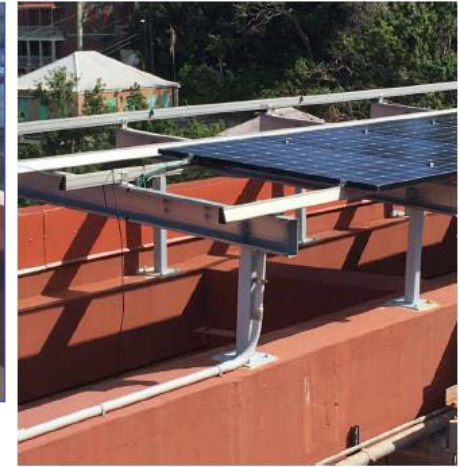
Uplift was seen with modules hanging out over parapet walls (e.g. windward side of building during the storm) and modules were totally detached from the rack in the storm.

## Recommendation:

- On existing arrays remove front row of modules, avoiding area of wind exposure.
- On new arrays, account for uplift and site panels to avoid overhang

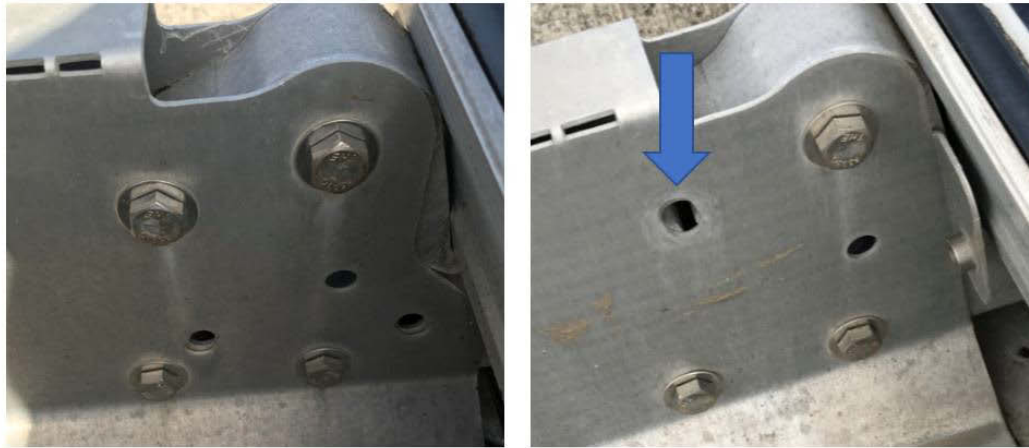
Bolts were missing from some brackets.

Recommendation:

- Install missing bolts and tighten to torque specifications
- Confirm torque specification during commissioning

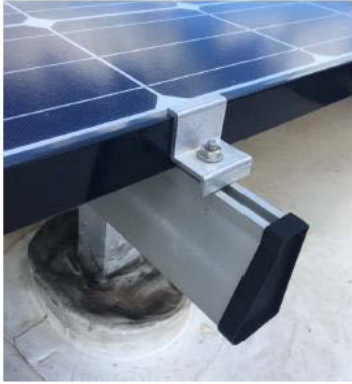
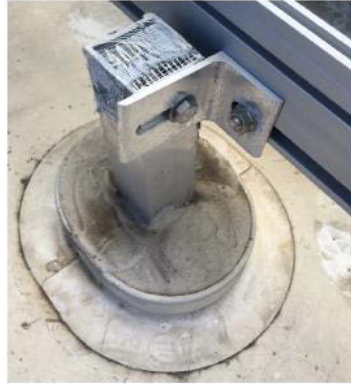
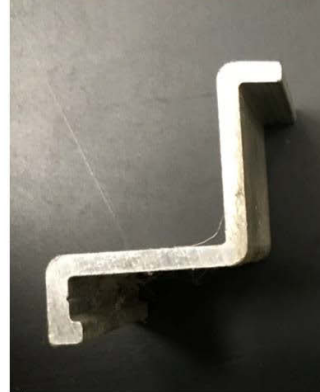
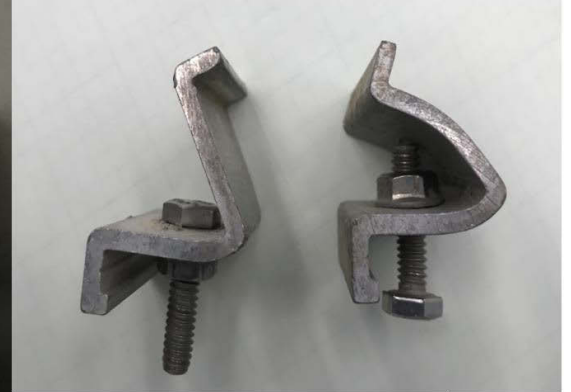
A commonly observed problem was that clamps holding the modules in position did not withstand sustained winds. Several end clamps were found in a bent condition indicating that bending of the end bracket released a module, creating motion/vibration, which then disengaged the next center clamp which held two modules down.

- Center clamp was stainless steel, marked 1R HA14, 70 psf, ETL UL
- End clamp was made of aluminum and unmarked

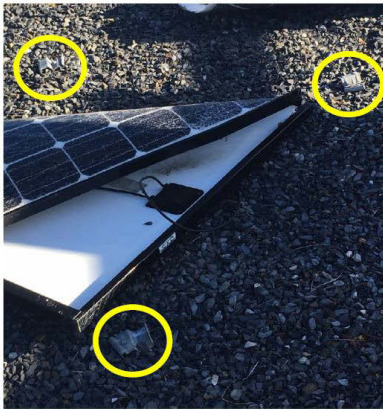
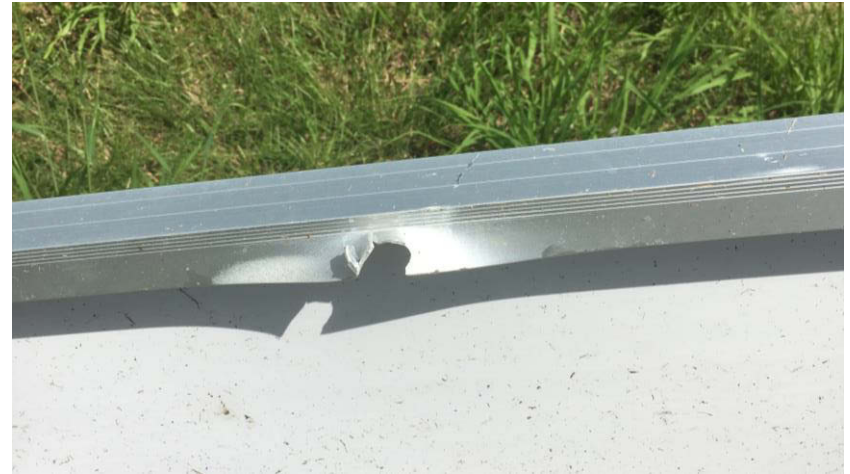
The clamps shown indicate the main failure (bent clamps) and a contributing factor related to the lateral braces which were held in place by only 2 self-tapping screws instead of four through-bolts. The frame on the right indicates a bolt ripping out of the framing.

## Recommendation:

- Consider through-bolting rather than clamping module frames.
- A combination of clamps and through-bolts may be used.
- Use the adequate number of clamps per module, per specifications.

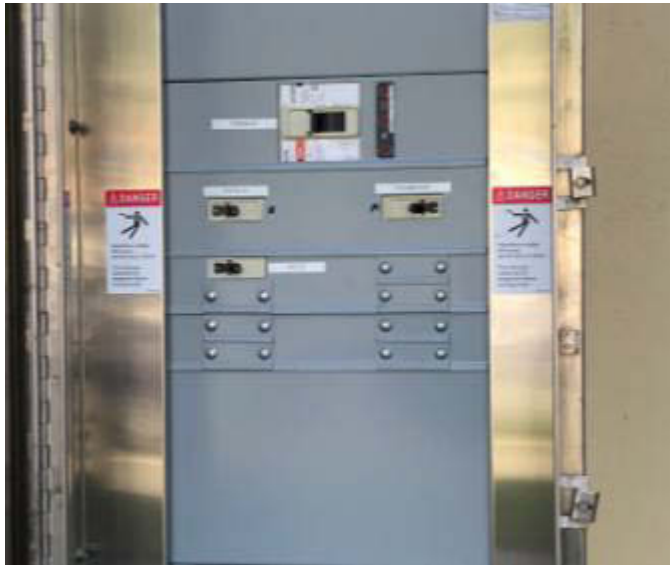
Condition	Number of Strings	Affected Modules
Bad	35	420
Okay	55	660
Total	90	1080

## Recommendation:

- For immediate deployment, move unbroken modules onto rack space where they are contiguous with modules of the same type and can be connected together electrically.
- Use stainless steel cabinets with multiple door attachments rather than single rod closures to prevent water intrusion.
