56th and Walnut—A Philly Gut Rehab Development

S. Puttagunta, O. Faakye, W. Zoeller
Consortium for Advanced Residential Buildings

July 2013

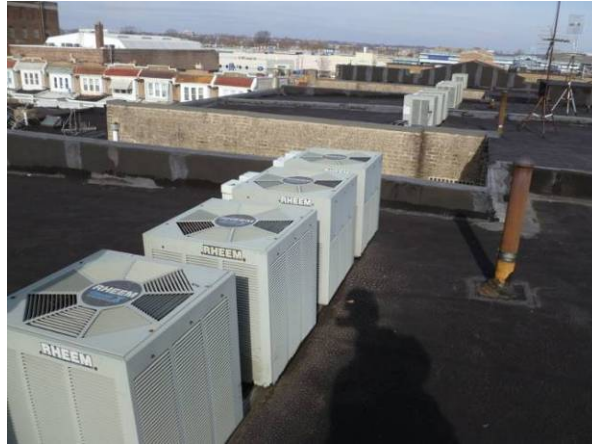
Figure 11. A/C condensing units on rooftop

The furnace units had a heating capacity of 45 kBtu/h with a burner efficiency of 90% AFUE. On the cooling side, 2-ton A/Cs with a SEER 10 rating were supplying each apartment. The cooling equipment was in poor condition. The condenser fins on many of these units were dented or damaged, debris was observed on the indoor evaporator coils resulting in restrictions to heat transfer and airflow, and the A/C units hadn't been serviced in years, so the refrigerant charge was likely low. Actual performance was estimated to be SEER 8 or less. Ductwork runs in the basement for the first-floor apartments (Figure 12), between floors for the second-floor apartments, and in the unvented attic space for the third-floor apartments. The existing sheet metal ductwork was uninsulated, in poor condition, and showed no signs of duct sealing.

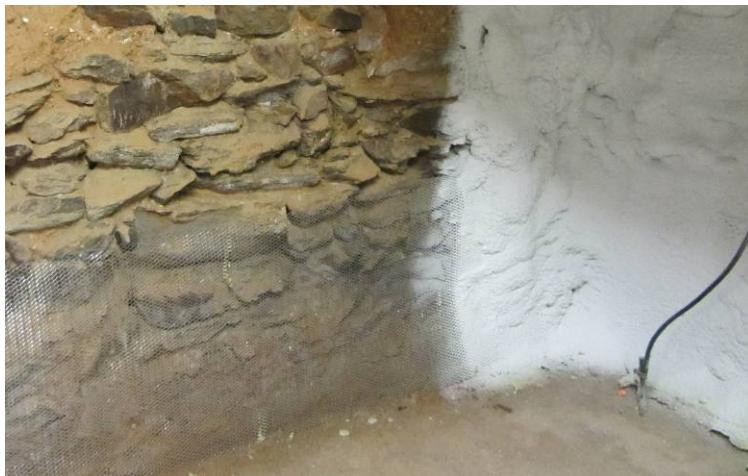
To apply the 3 in. of ccSPF to the rubble stone foundation took a bit of effort. As water and moisture were migrating through the lower portion of the foundation wall, having proper adhesion of the ccSPF directly to the foundation was a challenge. The project team ended up attaching wire mesh to the stone foundation and using that to form a dam of sorts a couple of inches out from the wall and then just filled the space with ccSPF. A spray intumescent coating was applied to the ccSPF insulation to provide a thermal/ignition barrier.

Figure 21. Wire mesh applied to bottom of stone foundation wall to help secure ccSPF in place

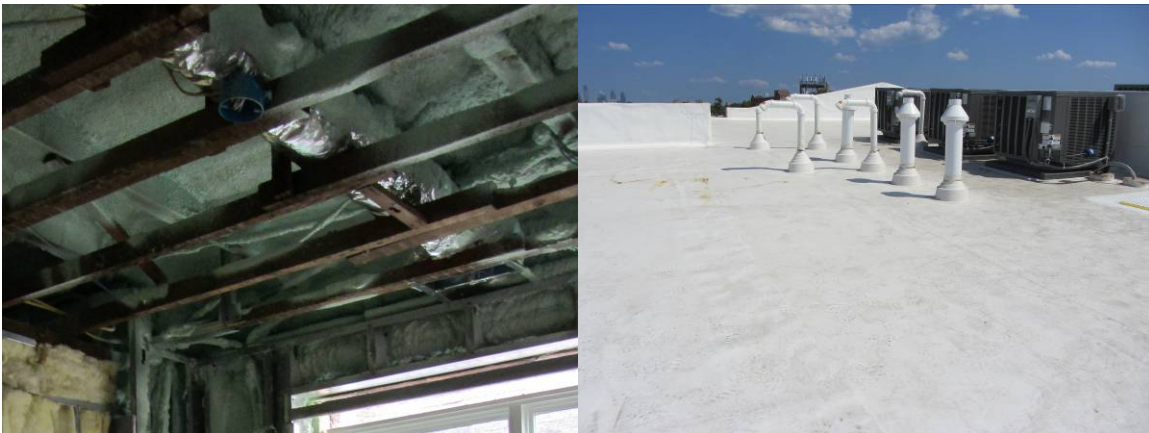
Figure 23. (L) 3 in. of ccSPF applied to underside of roof deck; (R) 3 in. of polyisocyanurate applied over the roof deck and covered with a white TPO membrane

The roof improvements for the third-floor apartments included 3 in. of polyisocyanurate insulation (R-19 continuous) placed above roof deck and 3 in. of ccSPF (R-19) on the underside of the roof deck to create a total roof assembly of R-38. A white TPO membrane was applied over the polyisocyanurate insulation to provide a reflective, “cool-roof” rated weathertight assembly.

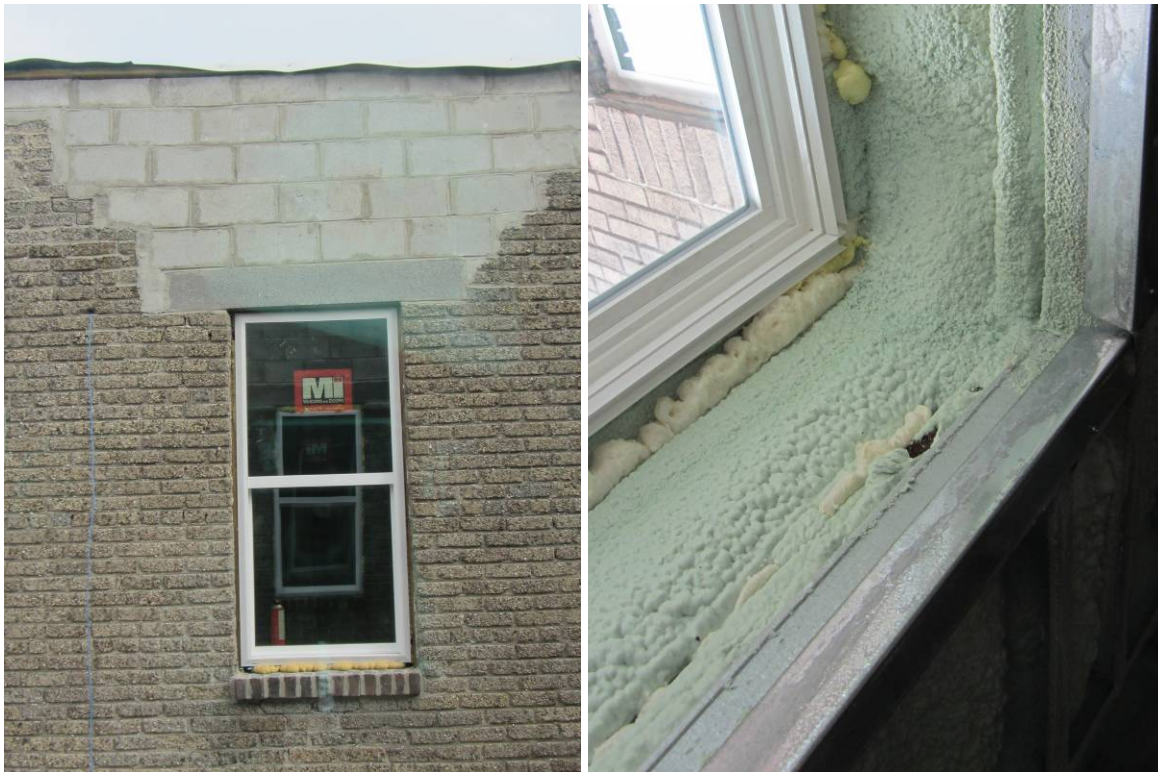
Figure 24. (L) Rebuilt window header; (R) ccSPF applied to rough opening to air seal and insulate

All windows were replaced with dual-pane, low-e windows with vinyl frames (U-0.29/SHGC-0.22). Prior to installing the new windows, those steel angle window headers that deflected had to be replaced. In addition, most of the rough openings for the windows had to be

rebuilt. Once the windows were installed, the interior surfaces were air sealed and insulated with ccSPF and the exterior surfaces were caulked.

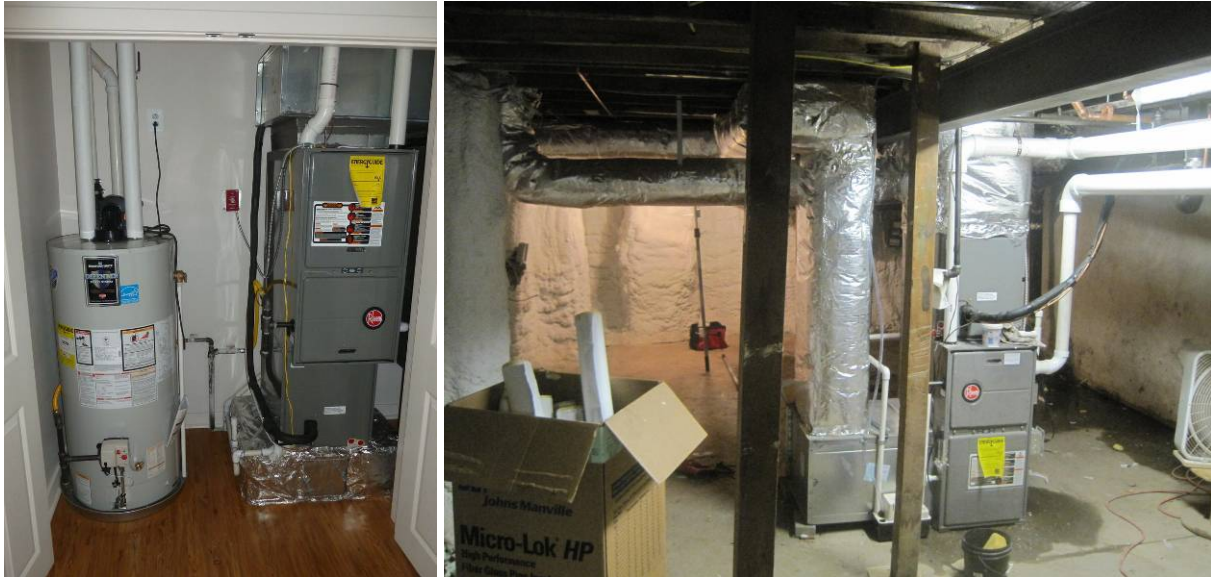
In addition to the performance testing, CARB inspected the overall project and found the installation of the HVAC systems to be a major improvement over the pre-existing systems (Figure 29). The previous concerns of CO spillage into the mechanical closets have been eliminated with the installation of sealed combustion and power/direct vented equipment. However, a CO detector was still installed in these closets as a safety precaution. The HVAC systems for the first floor apartments have been brought within the building envelope and the ducts properly air sealed and insulated.

Figure 29. (L) The furnace and water heater do not draw combustion air from the interior and direct exhaust flue gases to the exterior, so the risk of CO spillage has been drastically reduced. (R) This HVAC system located in a basement has been brought within the thermal envelope of the building and ductwork has been air sealed and insulated.

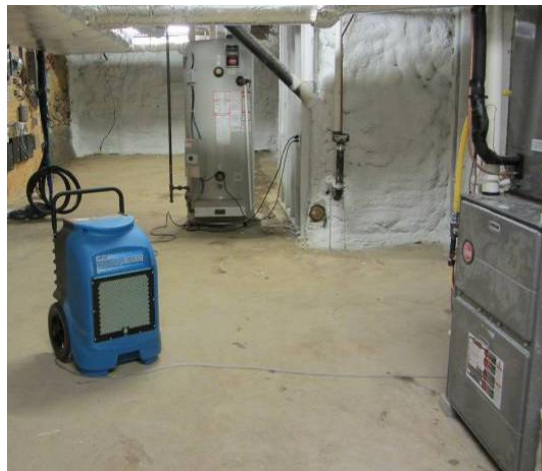
Figure 30. Stand-alone dehumidifier installed in a basement

To determine if a dehumidifier would be a sufficient solution to address the high RH levels in these basements, CARB set up temperature and RH sensors in two separate basements in the apartment complex; one with a dehumidifier and the other without a dehumidifier. The dehumidifier had a maximum moisture removal capacity of 145 pints/day.

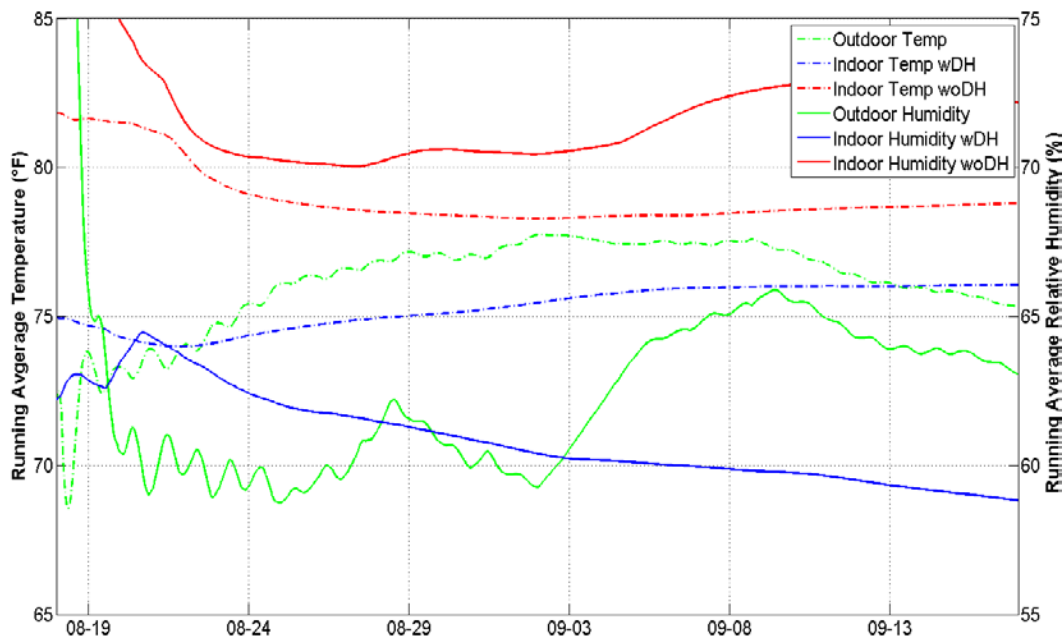
The running average of the RH readings from the basement without a dehumidifier ranged from 70%–75% and temperatures ranged between 78°–83°F. Although these conditions fall outside the critical thresholds for mold growth according to ASHRAE 160, data were collected for only one month. As temperatures drop outside, basement temperatures may also fall as they are not directly conditioned and duct leakage from the first-floor apartment ductwork has been minimized. If the excess moisture is not removed, RH levels could easily climb into the ideal range for mold and fungi growth.

The running average RH levels from the basement with a dehumidifier were below 65% and appear to be continually decreasing, unlike the basement without the dehumidifier. Temperatures ranged between 73°–76°F. The data indicate that the dehumidifier is reducing the RH levels in the basement to a safer level. However, as the basement is not directly conditioned, RH levels should continue to be monitored throughout the winter to ensure they do not climb into the range where mold growth is likely. CARB requested that the property manager periodically inspect the basements for moisture and to take temperature and RH measurements. CARB intends to follow up over the coming years to determine the effectiveness of this foundation system.

Figure 31. Temperature and RH 30-day running-average data

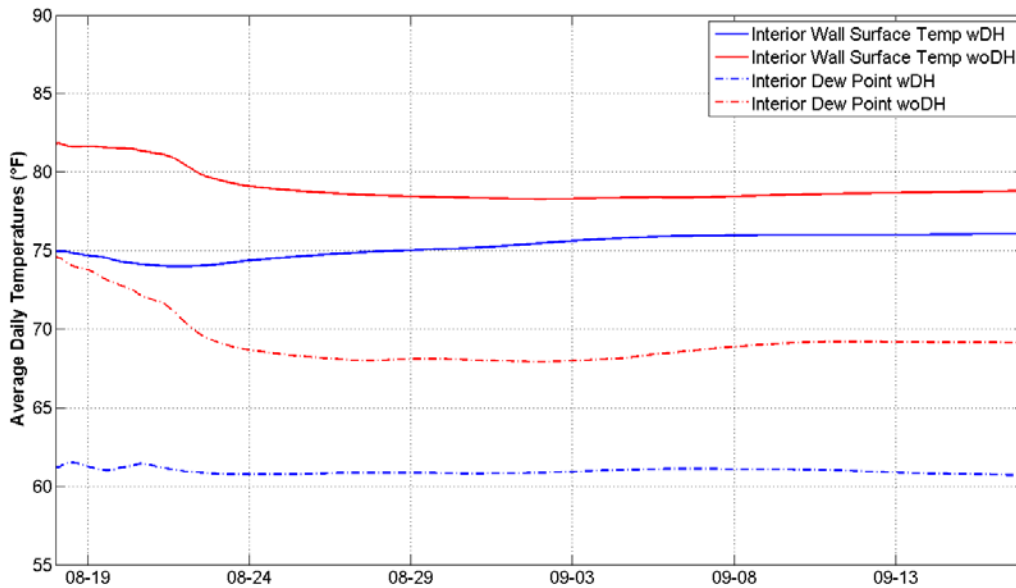
An alternative analysis method, condensation potential, was evaluated for the monitored period for each basement by comparing the interior air dew point temperature to the interior surface temperature of the basement walls. Interior surface temperature was predicted using THERM 6.3, a two-dimensional modeling tool used to evaluate heat-transfer effects in building components. The average daily recorded interior and exterior temperatures were used as the boundary conditions in THERM. As seen in Figure 32, over the monitoring period, there was no potential for condensation forming. The greatest potential for condensation would occur in the winter months, but to date, no signs of condensation in the basements have been observed at the site.

Figure 32. Measured dew point of interior air and modeled surface temperature of foundation wall
